Name of the public building renovation:		Complete reconstruction of municipal head office SLOVSEF programme
Description	Category	Financial/Technical/Legal tool
	Address	
	Photo

Public sector contractor	Slovak Energy and Innovation Agency
	Characteristic of Public Building	Municipal head Office (public body)
	Date of Construction	1951
	Date of Renovation	2011

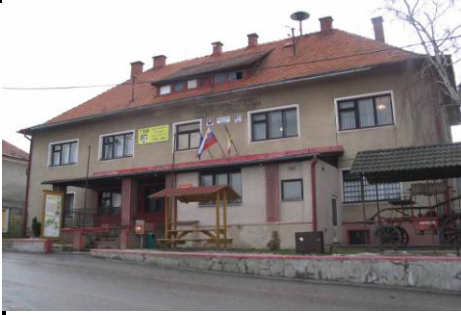
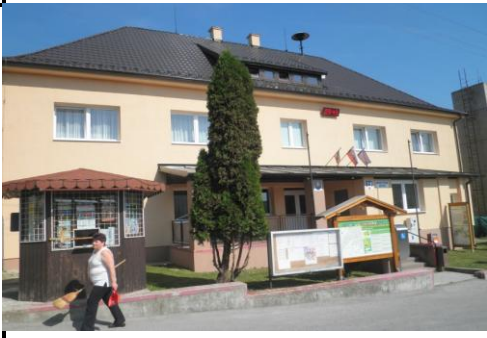
Implementation	Nature of the works	Thermal Insulation of External Walls - EPS thickness 80mm; Insulation of Unheated Floor of Attic - mineral wools 150 mm; Insulation of Unheated Floor of the Basement - EPS 60 mm; Exchange of Windows, Door and Glazed walls for plastic windows with insulation glazing; Exchange of Light Sources Renovation of Heating resource - installation of new condensing boiler
	Budget/Financial resources	State and Private financing
	Supervisor	EBRD
Energy savings	Methodology for savings calculation	Energy audit
	Savings calculation in 2012	Overall annual energy savings: 77,99 MWh
