BUILDING GOOD PRACTICE

Primary School N17 – Świętochłowice, Upper Silesia

GENERAL INFORMATIONS	
Name of the public building renovation:	Świętochłowice Primary School N17
Index of Building Good Practice (ex. BGP n°1 – IT)	BGP n°1 – PL
Sub-group	Historical buildings, schools
Description	Photo

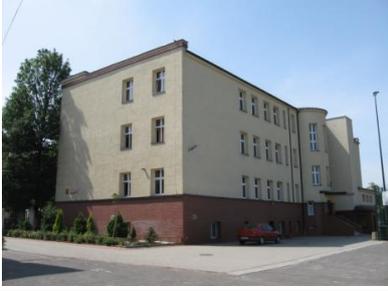
<p>saved)?</p>	<ul style="list-style-type: none"> - reduction in demand for thermal power of 44% i.e. 132,6 kW; <p>In building B:</p> <ul style="list-style-type: none"> - reduction in heat consumption of 70% i.e.545,28 MWh/year, - reduction in demand for thermal power of 29% i.e. 118,1 kW, - Total up (buildings A and B) in the process of modernization the estimated savings of heat come up to 1068,21 MWh/year.
<p>Ecological Effect</p>	<p>As a result of the project the emission of gases and dust decreased.</p>
<p>ENERGY EFFICIENT MEASURES</p>	
<p>Energy efficient measures of the building envelope</p>	<p>The thermal insulation of external walls and walls at the ground level:</p> <ul style="list-style-type: none"> - in building A - comprehensively, - in building B - only the gable-end of the fourth segment (from the yard) in consideration of the historical character of the building and restoration recommendation.

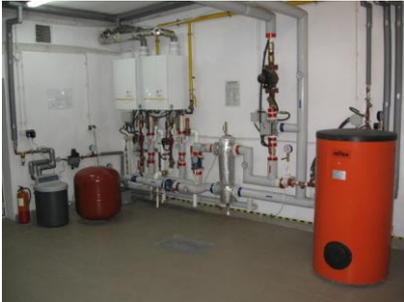
<p>Energy efficient measures of the heating system</p>	<p>The replacement of ineffective heating system based on solid fuel boilers (coke) with fully automatic high-duty heating system composed of gas condensing boilers.</p>

<p>Boiler rooms in both buildings are analogical.</p>
<p>Energy efficient measures of monitoring energy</p>	<p>The inclusion of the object into „Internet power management system” – administered by outsourcing company (REUS Poland), authorised to monitor the energy and media consumption. The system includes all public buildings except for The Health Care facilities. The City Hall and the administrators of individual outposts incorporated receives monitoring data.</p>
<p>Energy efficient measures regarding behaviour</p>	<p>Trainings are conducted by the Municipality and outsourcing company. The average frequency of training – every two years. In the meantime individual consultations are held over the phone and by mail. The training is for administrators as well as users (seldom).</p>
